Re: Structural Inspection for the 100,000 Gallon Cone Roof Elevated Tank

Dixon Engineering performed an inspection on September 30, 2020 on the 100,000 gallon cone roof water tower located in Plainwell, Michigan. The purpose of the inspection was to perform a general structural evaluation of the entire structure. The inspection was performed by James Rowley, PE and Paul Spitzley, PE.

100,000 gallon cone roof (Paper Tank) located in Plainwell, Michigan.

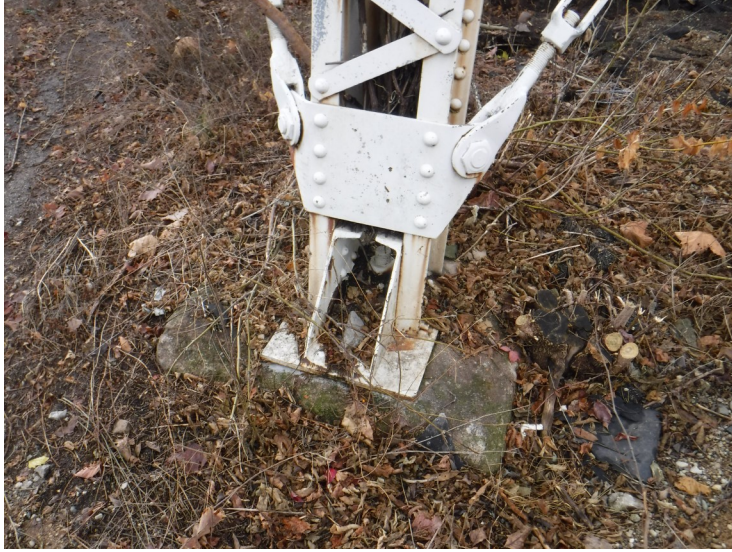
1) Typical leg is in good condition overall. The foundation concrete is in good condition.

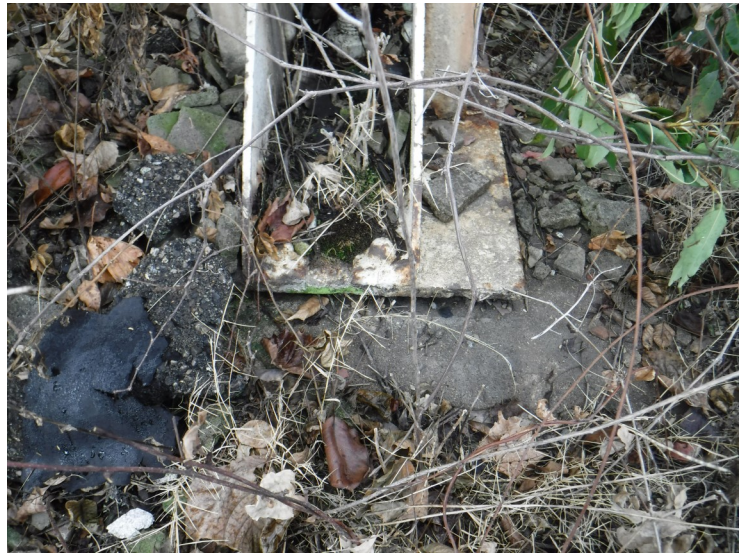
The grout between the baseplate and foundation is in fair condition on the legs and the riser. There is approximately 5 total lineal feet of grout missing on the legs.

2) Missing grout underneath a leg.

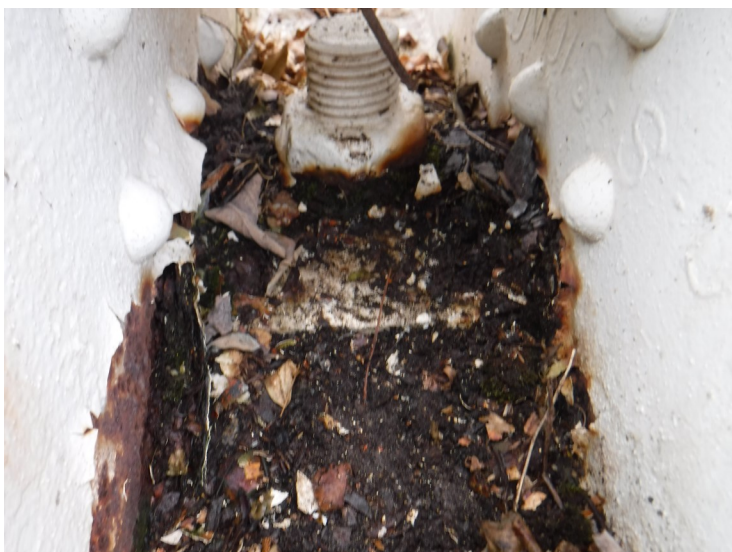
There is one anchor bolt located on each leg. The anchor bolts are in fair condition overall with some steel loss on some of the nuts and bolts.

3) Active corrosion of leg anchor bolt and nut.

2. Inspect the anchor bolts and nuts after abrasive blast cleaning to determine the amount of steel remaining and repair anchor bolts if necessary. The cost would be determined after the extent of repairs is known (if necessary).

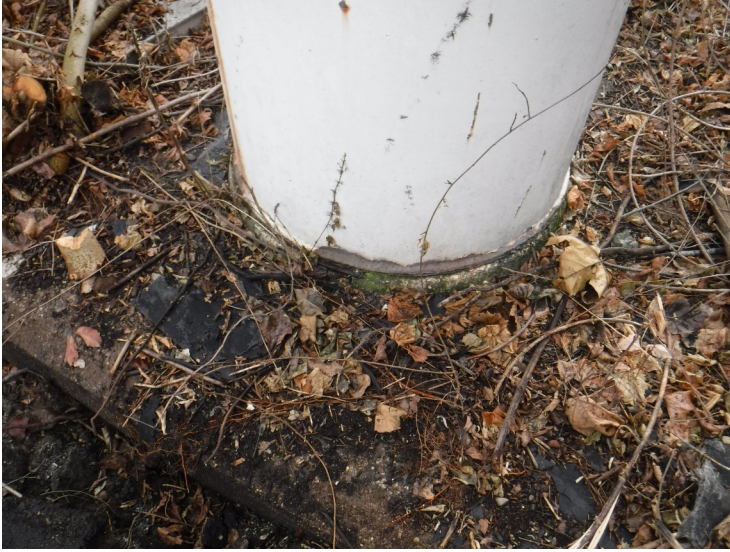
4) The riser foundation is in good condition.

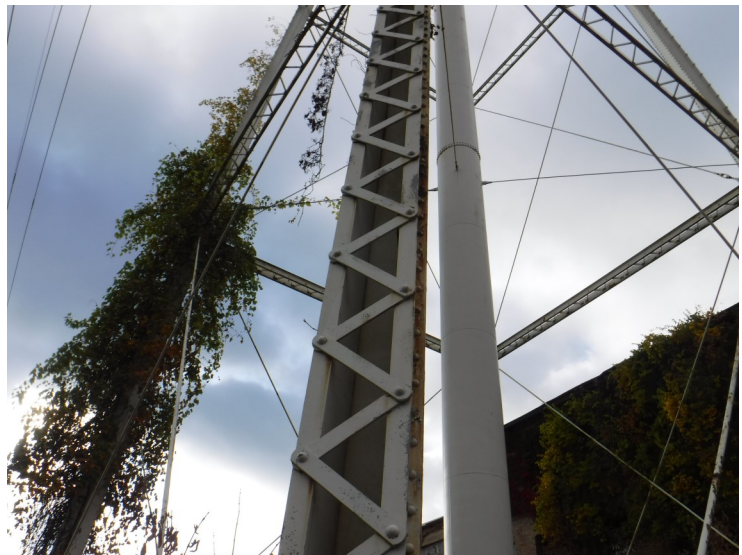
5) Typical lattice leg is in good condition. The coating is in poor condition.

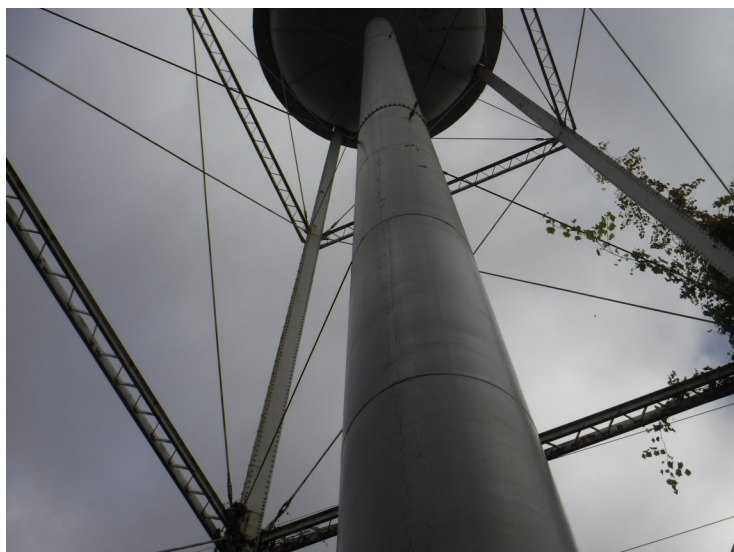
6) The riser is in good condition. The coating is in poor condition.

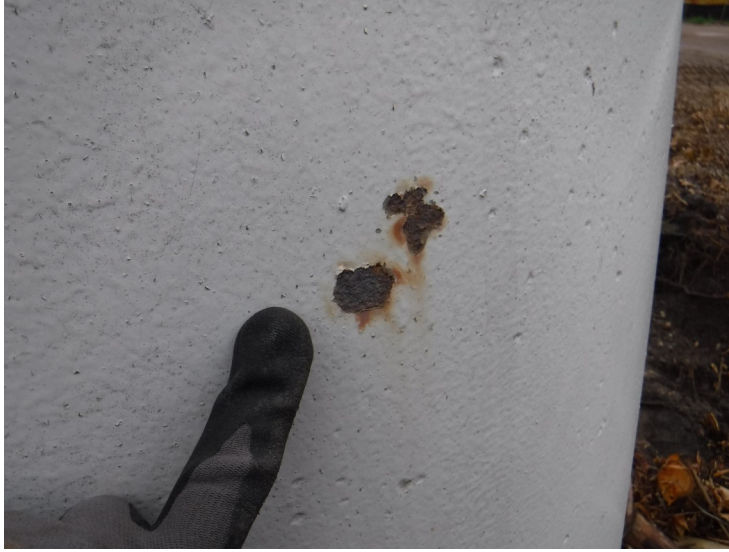
7) Coating failures on the riser.

1. Abrasive blast clean the exterior inside a dust tight containment system and repaint with a fluoropolymer system. Because of the nearby electrical transmission lines, a rigid containment system would be required. The estimated cost is \$230,000 plus \$350,000 for rigid containment.

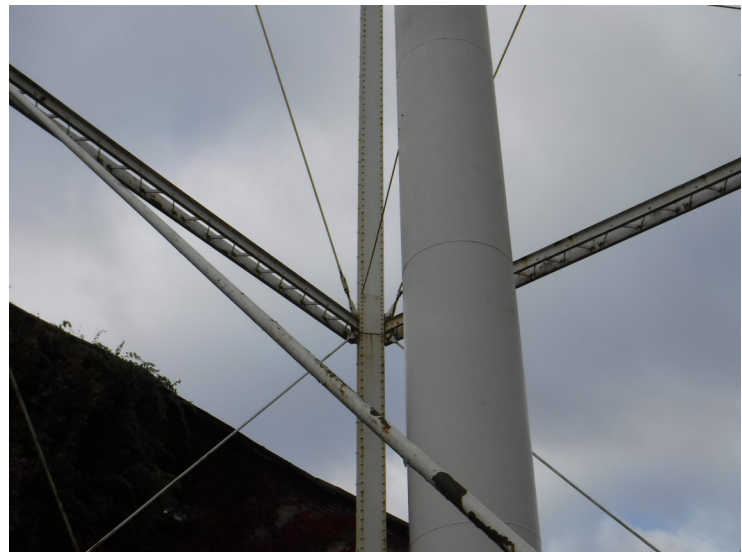
8) The sway rods are in good condition. The coating is in poor condition.

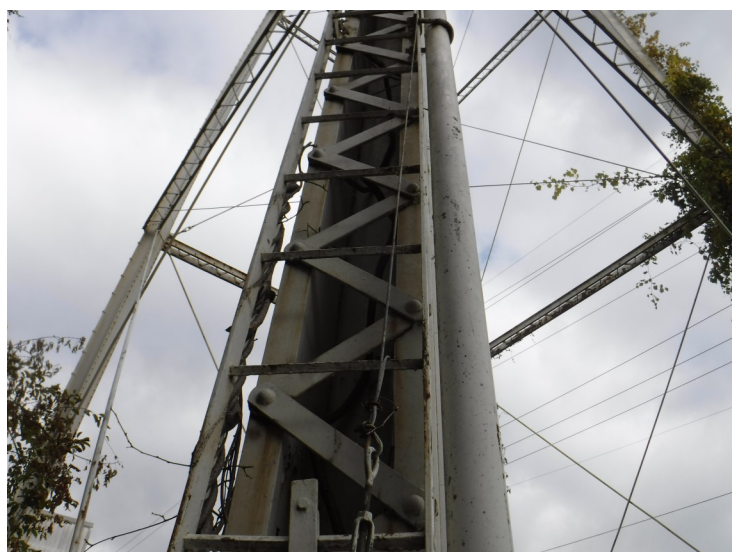
9) The leg ladder is in good condition. The ladder is equipped with a cable-type fall prevention device that is undersized.

8. Install a fall prevention device on the exterior ladders. The estimated cost is \$5,000.

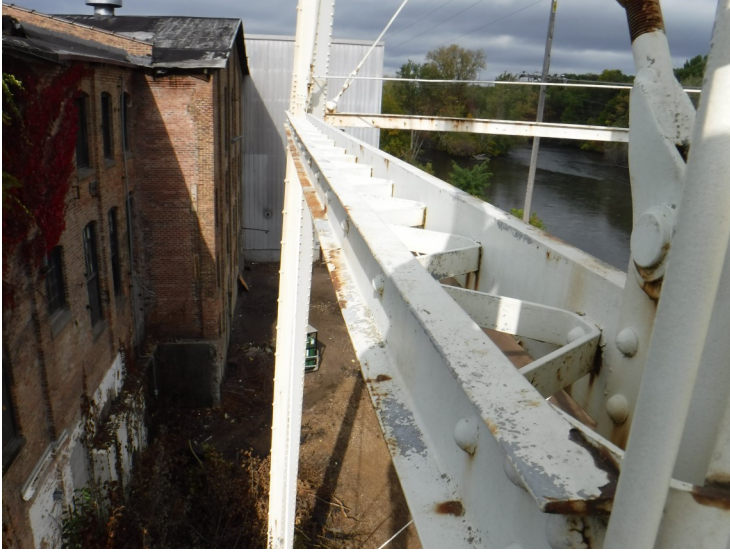
10) Typical strut is in good condition. The coating is in poor condition.

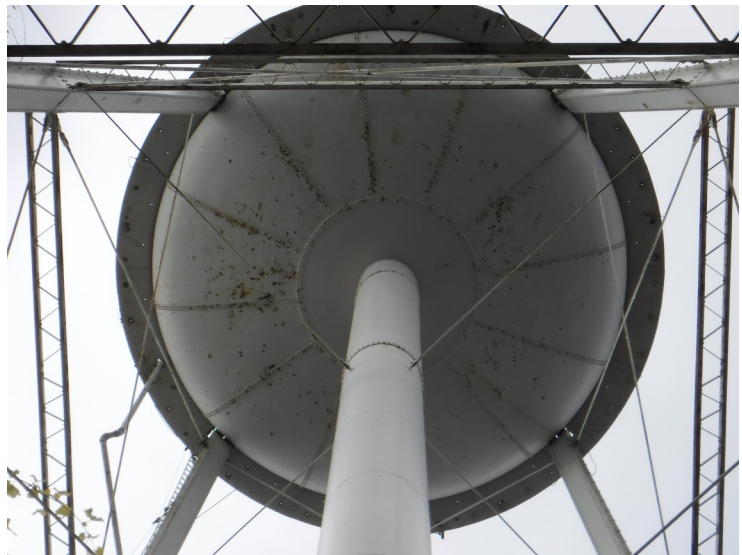
11) The bowl is in good condition. The coating is in poor condition.

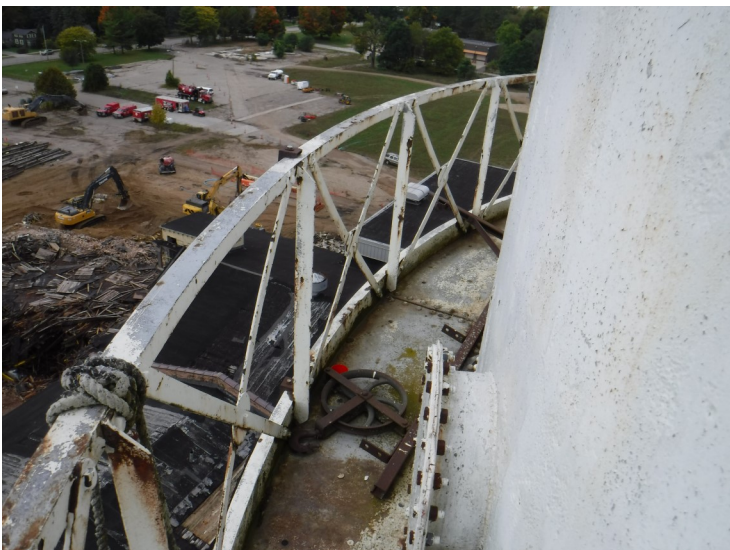
12) The balcony is in fair condition. The coating is in poor condition.

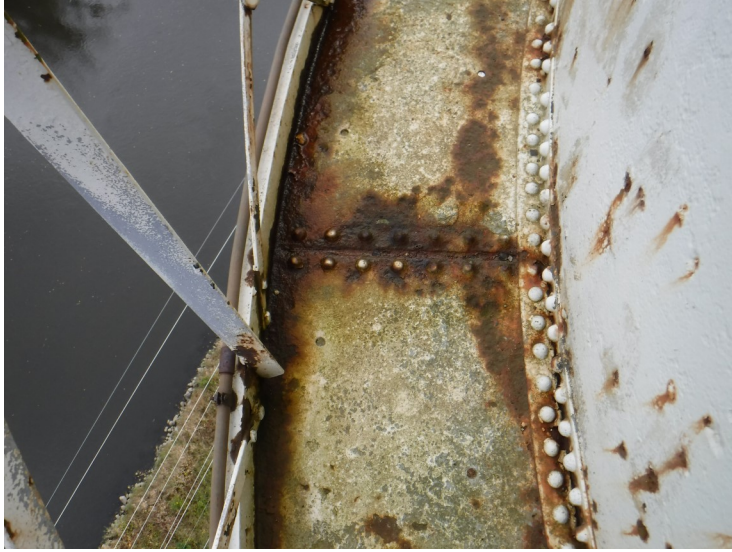
The exterior balcony is in fair condition overall. There is corrosion with some steel loss on the balcony floor plate. The balcony and railing do not conform to current OSHA requirements. The railing height is undersized and there is no midrail. The balcony does not contain enough drainage holes and water is ponding on the walkway. The tank does not have a roof handrail.

13) There is evidence of water ponding on the balcony. There is active corrosion occurring on the floor plates.

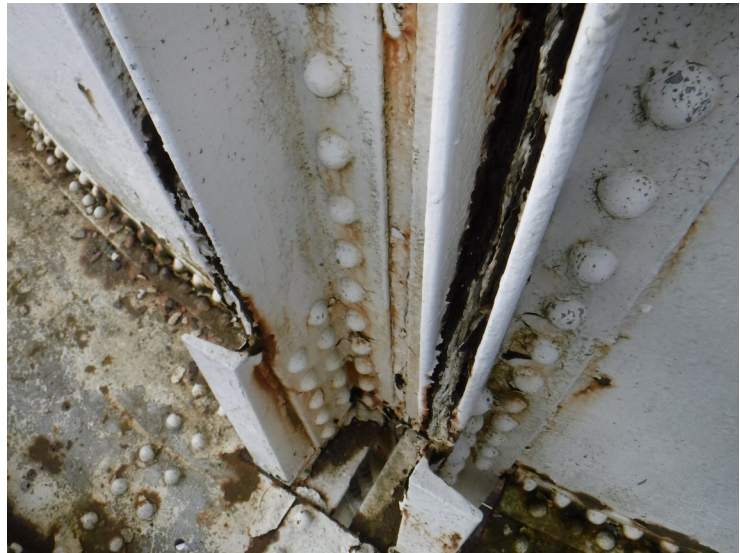
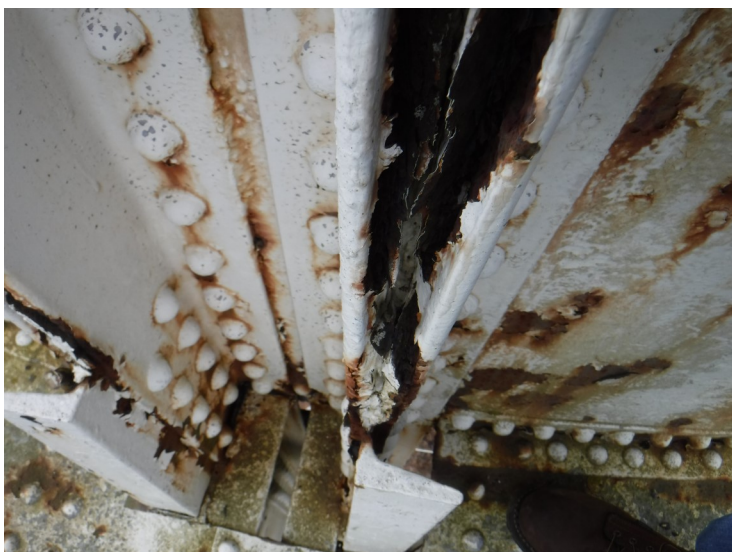
14) The leg to bowl connection is in poor condition. There is active corrosion in the crevices.

15) Same.

3. Remove soil at the foundations to expose the top 4 inches. The work can be performed by in-house personnel.
4. Repair the leg to tank connections with welded patch plates. The estimated cost is \$40,000.

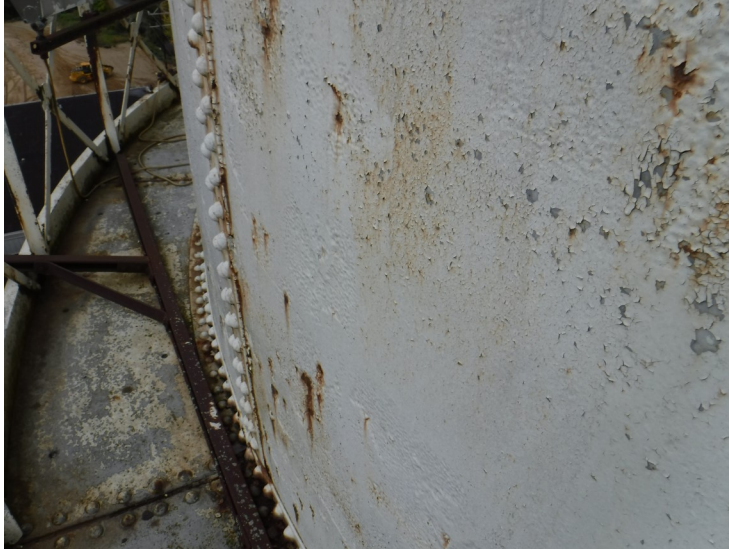
16) The sidewall is in good condition overall. The coating is in poor condition.

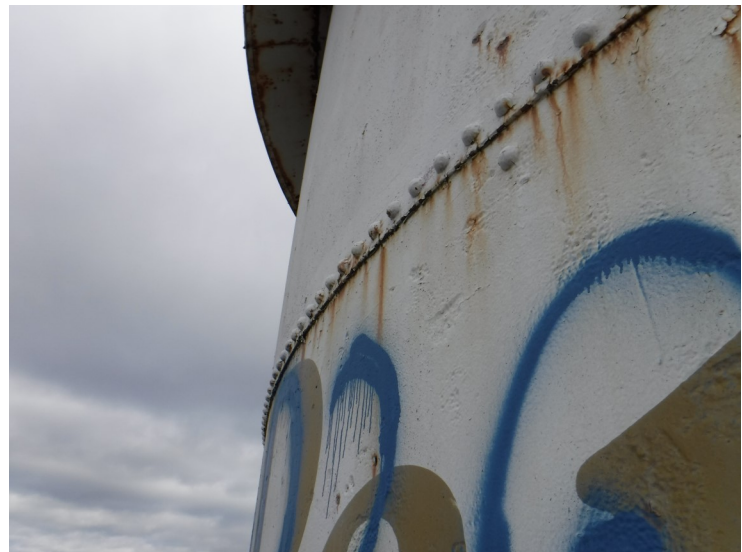
17) There is graffiti on the sidewall.

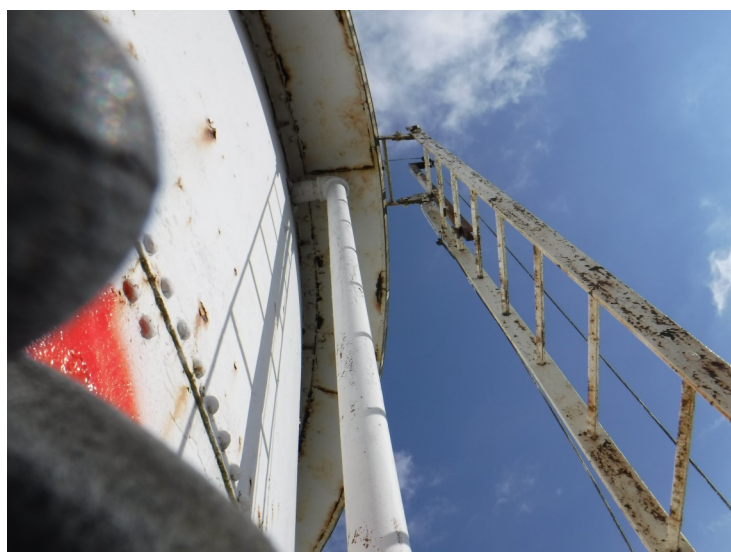
There is a revolving ladder that extends from the outside of the balcony up to the center of the roof. The ladder is in good condition overall but is unstable. The only connection point of the ladder is at the center of the roof. The ladder is equipped with a cable-type fall prevention device that is undersized.

18) The rotating sidewall ladder is in fair condition. The ladder is equipped with a cable-type fall prevention device that is undersized.

6. Install a vandal guard on the leg ladder and each of the lattice legs. The estimated cost is \$10,000.
7. Weld the sidewall/roof ladder in place to keep it from rotating. The estimated cost is \$2,000.
